# **NAVIGATION SAFETY NOTICE**

**Number:** 05/2020

**Message:** No. 3 Beacon Port Nelson is missing

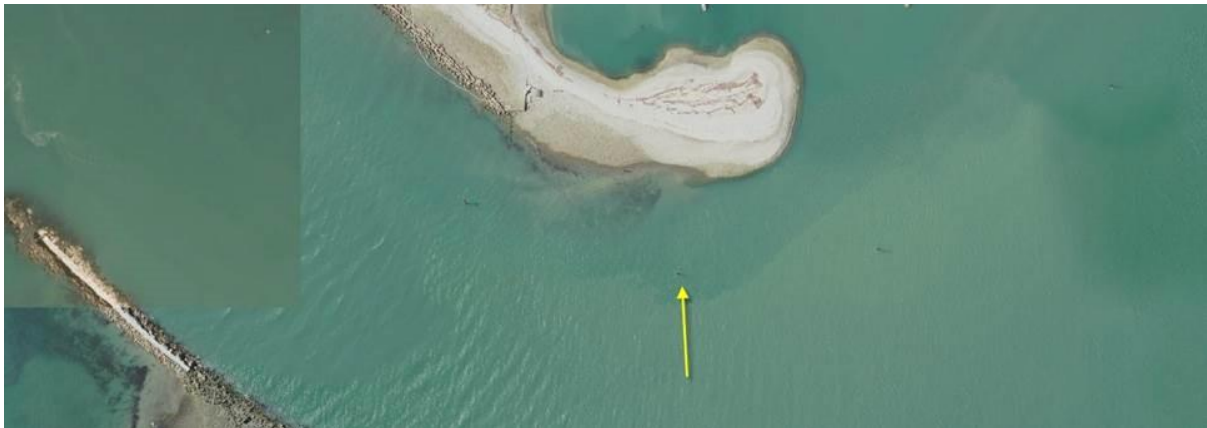
No. 3 Beacon (Light characteristic Iso R 2s) Position - 41° 15.82S 173°15.65E marking the extremity of the dredged channel has been knocked over. A temporary orange buoy with an orange flashing light has been put in its position until such a time a new pile can be driven.

Vessels are to navigate with caution when transiting the cut.

The beacon will be replaced as soon as is possible.
